GROUP ENG	MODEL 2020MY Soul (SK3) 1.6T
	NUMBER 203	DATE March 2019
TECHNICAL SERVICE BULLETIN		
SUBJECT: SERVICE ACTION: ECU LOGIC IMPROVEMENT FOR DTC P0606 (SA377)

SERVICE ACTION: ECU LOGIC IMPROVEMENT FOR DTC P0606 (SA377)

414.SK3 GAMMA 1.6TGDI 7DCT ECU MIL ON DTC (P0606) LOGIC IMPROVEMENT

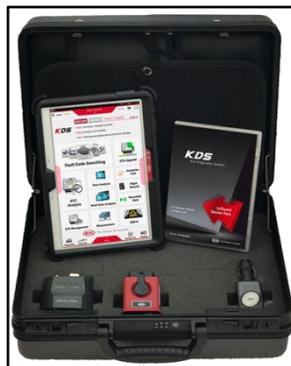
DTC: P0606 – ECM/PCM Processor

To correct this condition, the ECU should be reprogrammed using the KDS download, as described in this bulletin.
